TRANSMISSION 725.0 in MODEL 217, 222

Phantom view of vehicle; illustration shows model 222

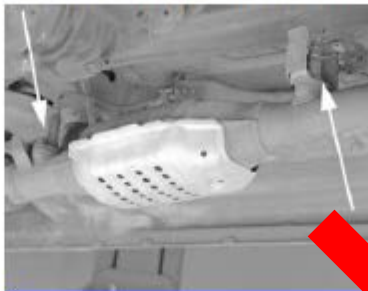
Since sensor locations vary between vehicles, the first step in removal is to locate the O2S sensors (arrows)...

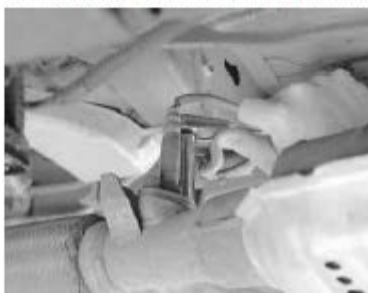
For flange type sensors, loosen the hold-down fasteners...
